DELAWARE RIVER BASIN  
TRIBUTARY TO HAYNES CREEK  
BURLINGTON COUNTY,  
NEW JERSEY

**LOWER AETNA  
LAKE DAM  
NJ 00418**

**PHASE 1 INSPECTION REPORT  
NATIONAL DAM SAFETY PROGRAM**

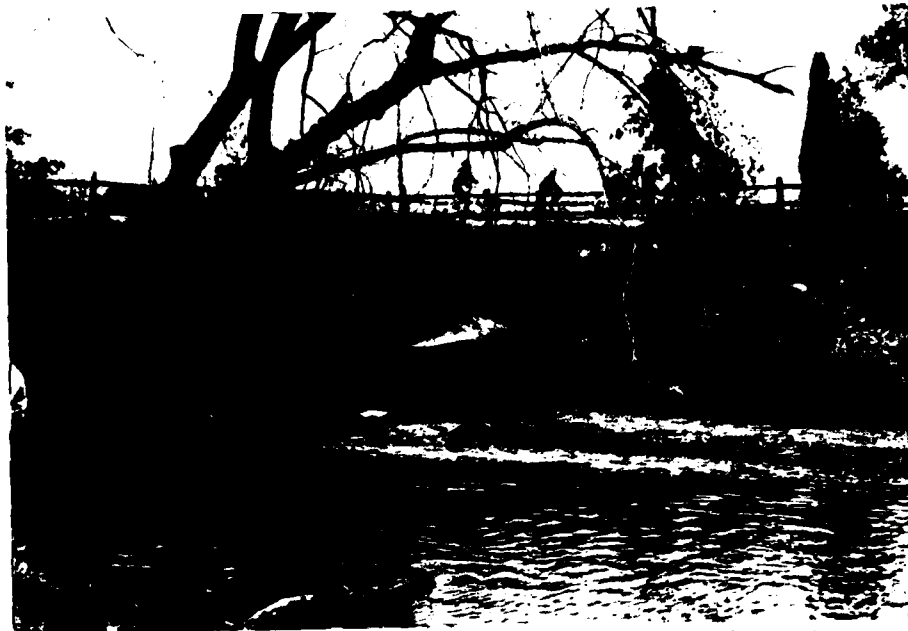
## SPILLWAY No. 2

View of Outlet
